Repairing an ICOM IC-970A

By Joseph Haas, KE0FF

5/14/2020

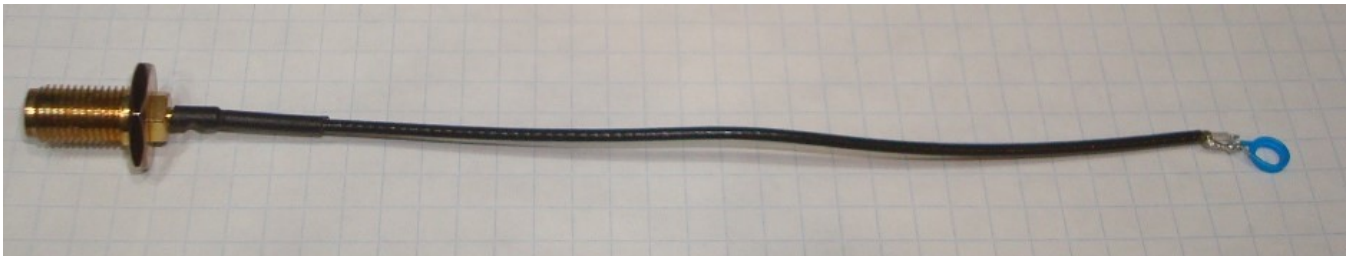
In the end, I decided to use a "current" probe and my spectrum analyzer (S/A) to look at the signal between the stages. I've used commercial probes in the past, but they are very expensive, so my probes simply consist of a short piece of coax with an SMA on one end, and a small coil, about 1/8" diameter, with 4 or 5 turns of wire-wrap wire soldered to the other. I probed the input to the driver module (the pre-driver transistor is on the bottom of the PCB, so I decided to put off looking at its input until seeing the outcome of the top-side tests) and noted the peak signal level. Then I repeated this at the output of the driver module. I saw over 30 dB of gain which is a reasonable figure. At the input to the PA module, I saw a level consistent with what I saw at the output of the driver which is another good validation point. However, at the output of the PA, I saw around 10 dB of LOSS across the PA. Not good.

QTY One, MARK-I, regulation current/magnetic probe.

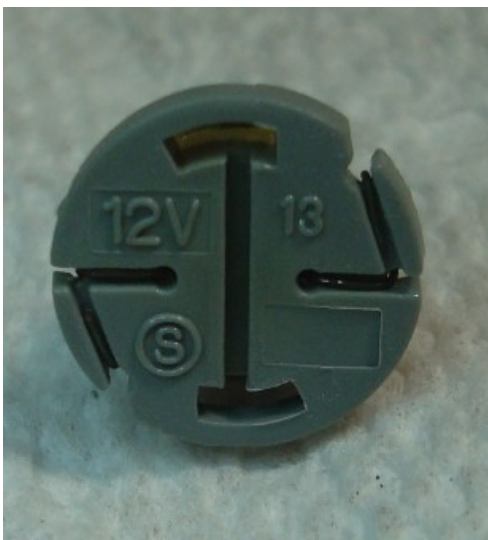
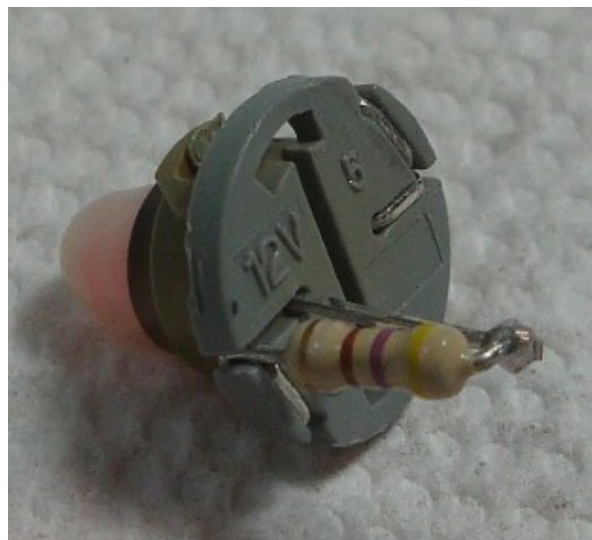
The bulbs for the LCD in the IC-970 use small plastic holders and are removable without having to use soldering techniques. This makes the process pretty straightforward. The meter bulb was wired, so it took a bit more effort, but was still easy to accomplish (see the end of this document for a step-by-step account of the replacement technique). The holders passed the bulb leads through some grooves that ultimately provided a contact surface for a mating PCB trace. The holders were slotted and could be installed/removed with a quarter turn of a small flat-blade screwdriver. Using a DMM, I measured the voltage at the lamp “sockets”. I wanted to know the voltage, and also the polarity. I marked a “+” next to the positive contact at each port.

Unmodified lamp holder (left). LED-modified lamp holder (right) – the resistor is the (+) terminal.

I first removed the silicone lamp cover and then un-threaded the incandescent bulb leads which allowed the bulb to slide out of the holder. If you are inclined to replace the bulb with another incandescent, you simply reverse the process, and re-install the lamp. For the LED, I used a leaded type that I have employed in other lighting applications. It is a high intensity red LED which meshes well with the amber background of the LCD display. Amber LEDs are available, but their intensity levels are usually pretty low. White can also be used, but I liked the red result better.

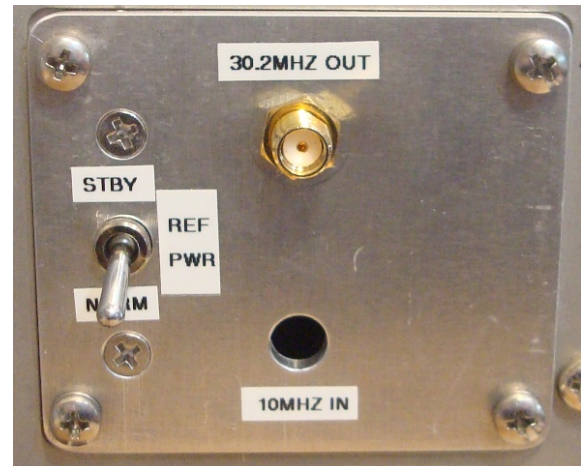
To the right: The reference control panel installed at the rear of the IC-970 (the 10MHz input jack will be placed when the frequency lock installation is performed).

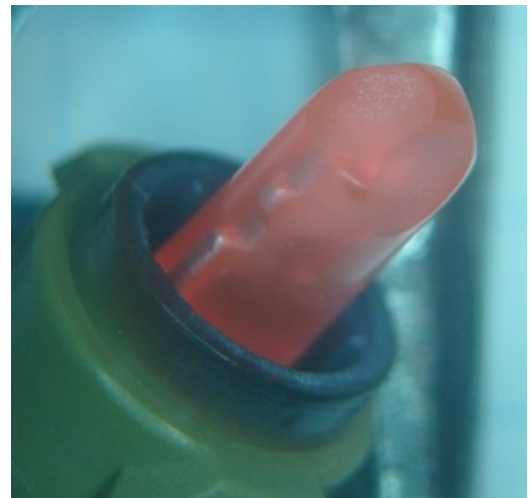
LED preparation: Secure the leads of the LED in a vise and use a Dremel tool with a standard cutoff wheel to grind 4 facets into the sides of each of the LEDs (see the image below for a detail of the facets). Be careful, you basically only need to lightly “kiss” the LED with the wheel moving at low RPM.

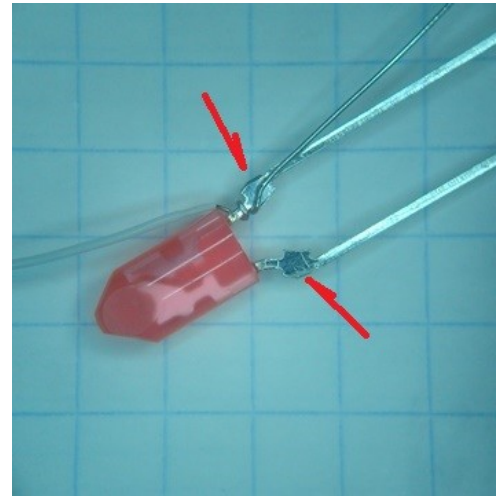
Step 2: Bend the LED leads as shown in the image below. Carefully trim the outside corner of the PCB stops (2 places, indicated by the arrows). Strip 2" of WW wire and tightly wrap around the cathode lead of the LED as shown. Apply a small amount of solder to the area between the PCB stop and the LED body. Avoid getting solder on the main part of the LED lead.

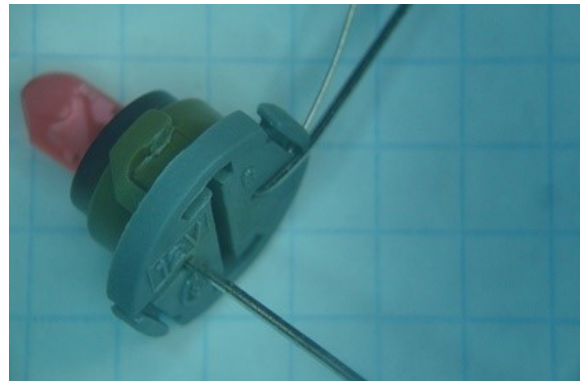
Step 3: Trim the spool side of the WW wire and align the attached bare wire to run parallel with the LED lead. Carefully guide the LED leads into the lamp holder making sure that the WW wire is on the outside edge of the LED lead. I use the hole nearest the "12V" embossed text as the anode (+) lead. Bend the WW wire and then the LED cathode lead at a 90 degree angle as shown.

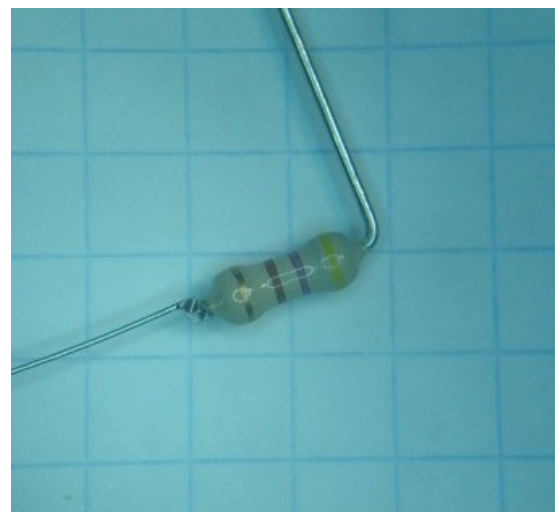
Step 4: Prepare the 1/4 W resistor as shown below. First bend both leads 90 degrees next to the resistor body. Then, strip 2" of WW wire and tightly wind 2 or 3 turns on one of the resistor leads as close to the body of the resistor as possible. Apply a small amount of solder to the WW wire joint and carefully trim the spool side of the WW wire and then trim the resistor close to the soldered connection. There should be about 2" of bare WW wire in place of one of the resistor leads.

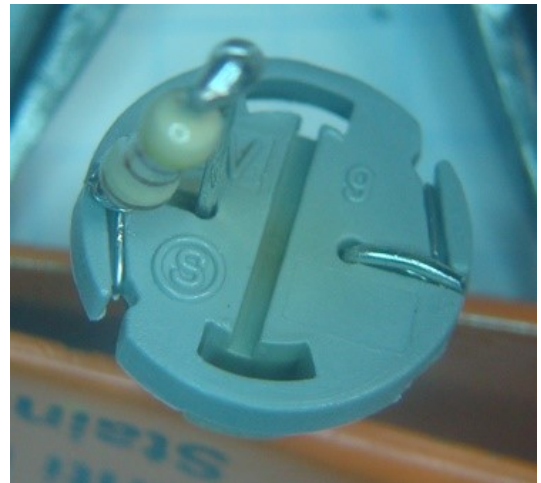
Step 5: Bend a 180 degree loop in the remaining resistor lead (NOT the WW wire lead). This loop is then positioned to wrap around the LED anode lead that is sticking straight out of the holder while the bottom of the resistor and the WW lead rest in the groove in the side of the holder as shown at the right. Carefully crimp the resistor lead loop onto the LED lead and solder. Trim the leads.

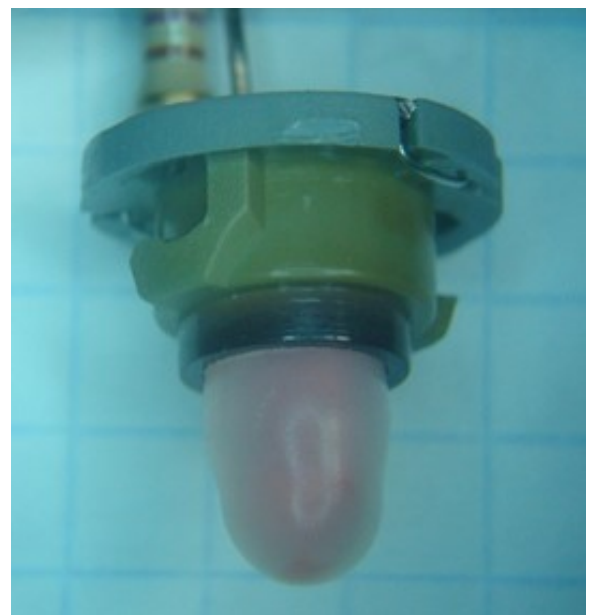
Step 7: Place the silicone boot over the LED and carefully tuck it inside the hole in the holder where the LED is located. If desired, tack the boot with a small drop of RTV at 2 or 3 spots where the boot meets the holder. Be careful to avoid having any adhesive extend out over the outer diameter of the LED arbor.

Note: If the boot is missing or damaged, it might be possible to use some translucent RTV to get the same effect. Apply a thin coat to the surface of the LED and allow to fully cure (at least 24 hours, more is better) before installing in the LCD module.

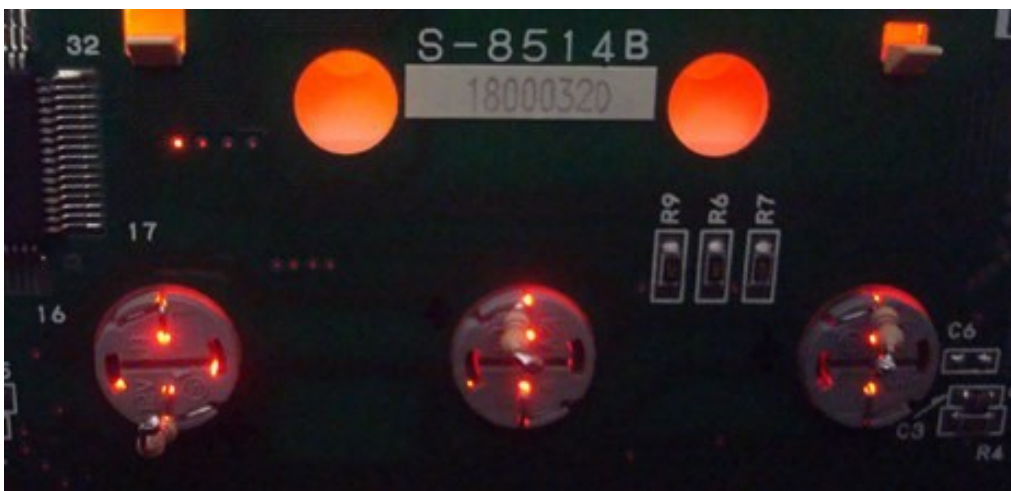
This is a view (with subdued ambient light) of the back of the LCD with the lamps operating:

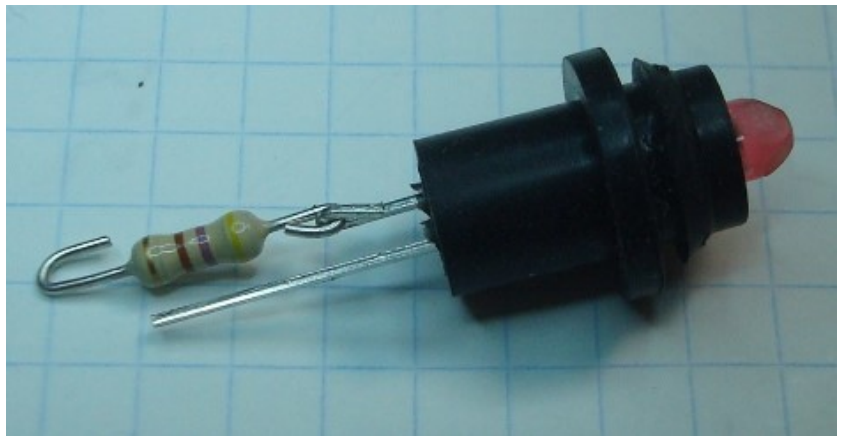
Step 3: Insert the prepared LED into the housing. Bend the anode lead of the LED, and the resistor leads as shown to the right. Crimp the resistor and LED leads together and solder. Bend the cathode lead in the same fashion as the anode lead. Cut heatshrink sections long enough to cover the two leads plus at least 0.25".

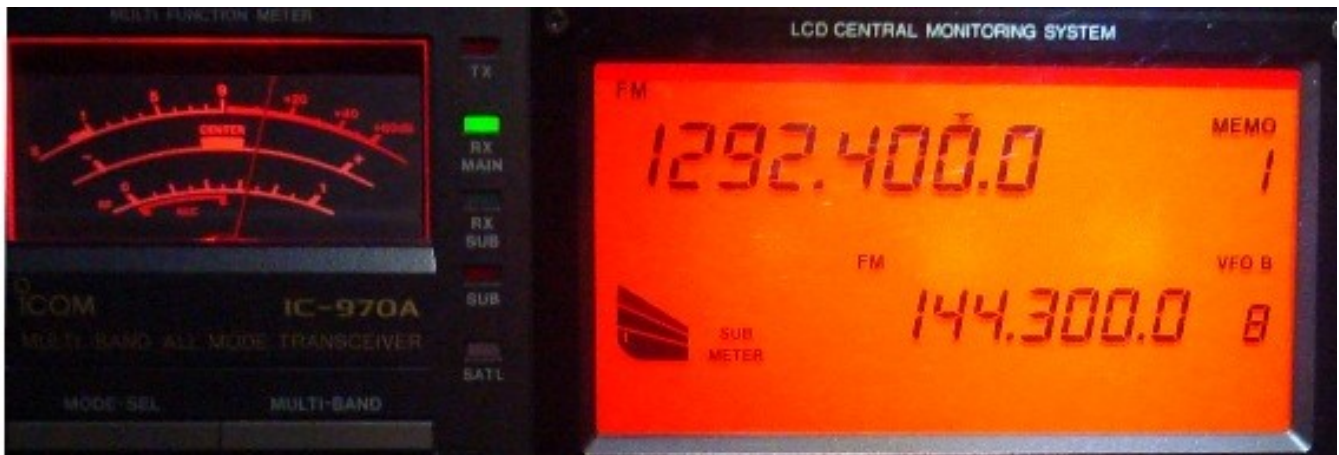
This is my result:

The image was “staged” a bit (I had to shine some ambient light onto the LCD to get a decent image, which serves to wash-out the backlight somewhat) and is not as representative of the actual appearance as I’d like. However, my photography skills and equipment are rather limited and this represents the extent of my capabilities in this regard.

The three “hot-spots” from the LCD backlights are slightly more pronounced than the image above suggests. I found full brightness to be most preferable as the relative brightness of these “hot-spots” was such that they appeared less pronounced than at the dimmer settings. I am pleased enough that I don’t feel compelled to put any more effort into the task. A better diffuser at each LED would be the goal for the those with a more discerning eye.
